WADC TECHNICAL REPORT 54-159

EVALUATION OF AN EXPERIMENTAL PLYWOOD-POLE LITTER

GEORGE W. HOGAN
AERO MEDICAL LABORATORY

MARCH 1954

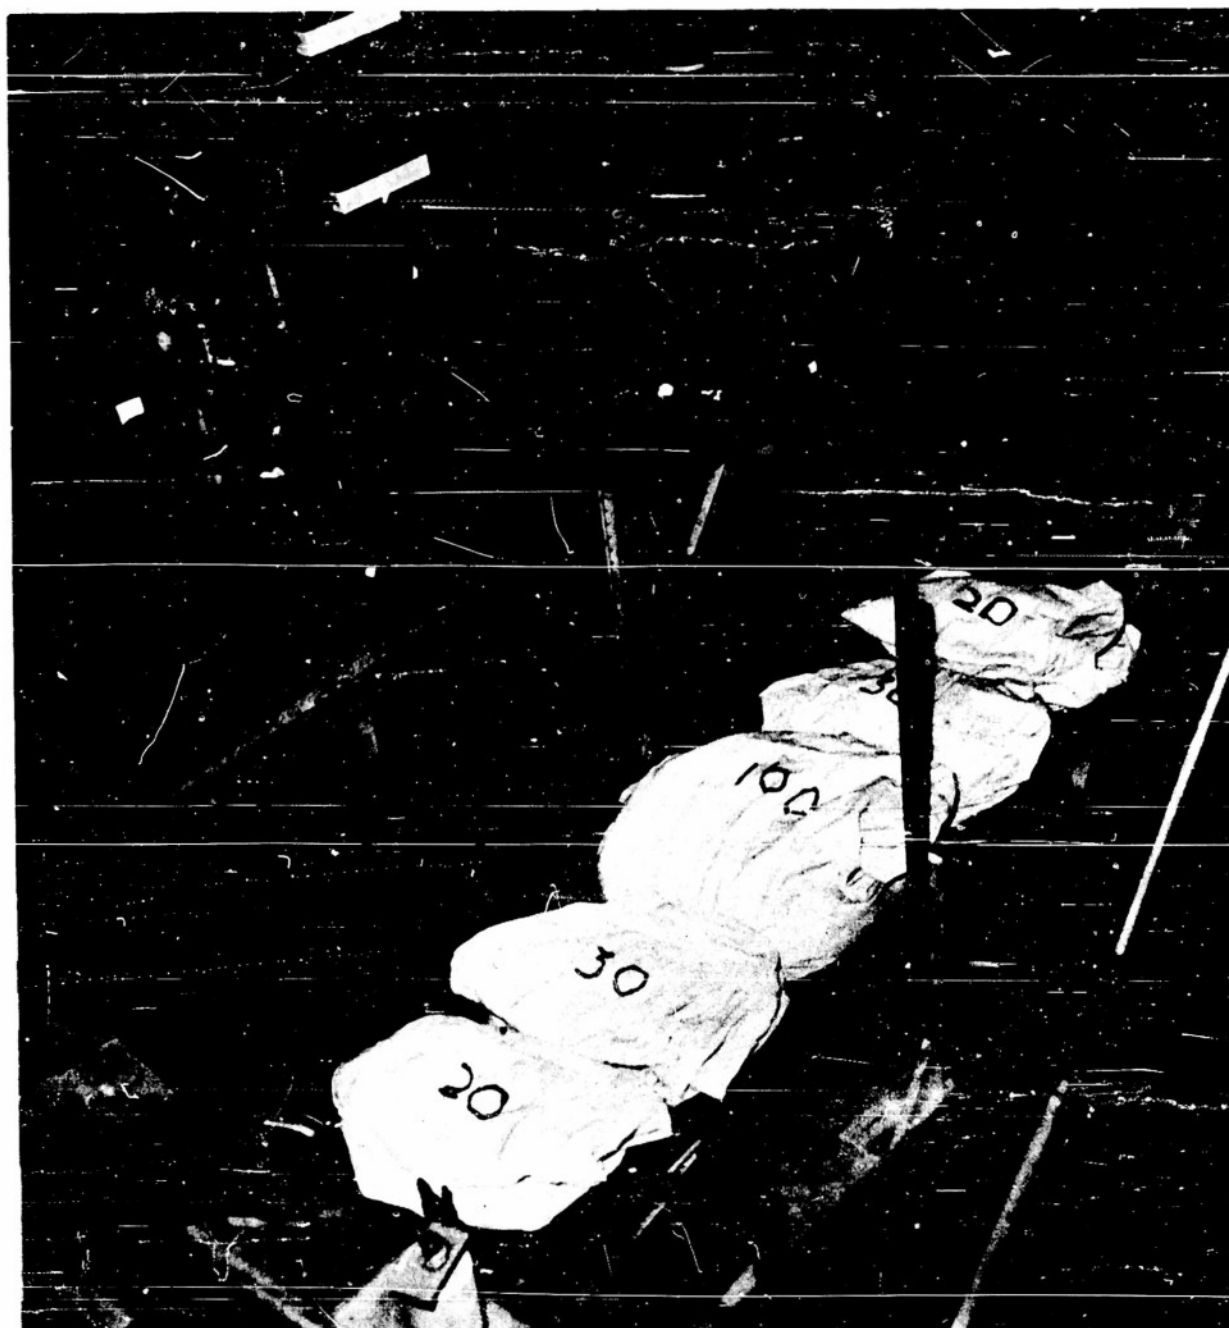
Figure 1
METHOD & PATTERN OF LOADING, Par. 4.3.1. MIL-L-16462

4. The overall weight of each litter was determined.
5. Various physical tests were conducted on one litter of each type as follows:
 - a) Two hundred pounds were placed on the litter cover canvas, with the litter suspended from four points located 37½ inches from the center of each pole. This weight was distributed as follows: 100 pounds over the center 18 inch length and full width of canvas; 30 pounds over each adjacent 15 inch length and full width of canvas; and 20 pounds over each end 12 inch length and full width of canvas. Measurements of the downward deflection of the pole centers were made. Figure 1 illustrates the method and pattern of loading.

7. Each of the six litters was subjected to a test for "ultimate strength". This test consisted of applying an initial load (see results for initial loading) to the litters and increasing this load by 10 pounds every two minutes until failure occurred. The loading pattern was according to procedure No. 5a and the points of suspension were located 39-3/8 inches from the center of each pole. Refer to Figure 1 for method of testing.

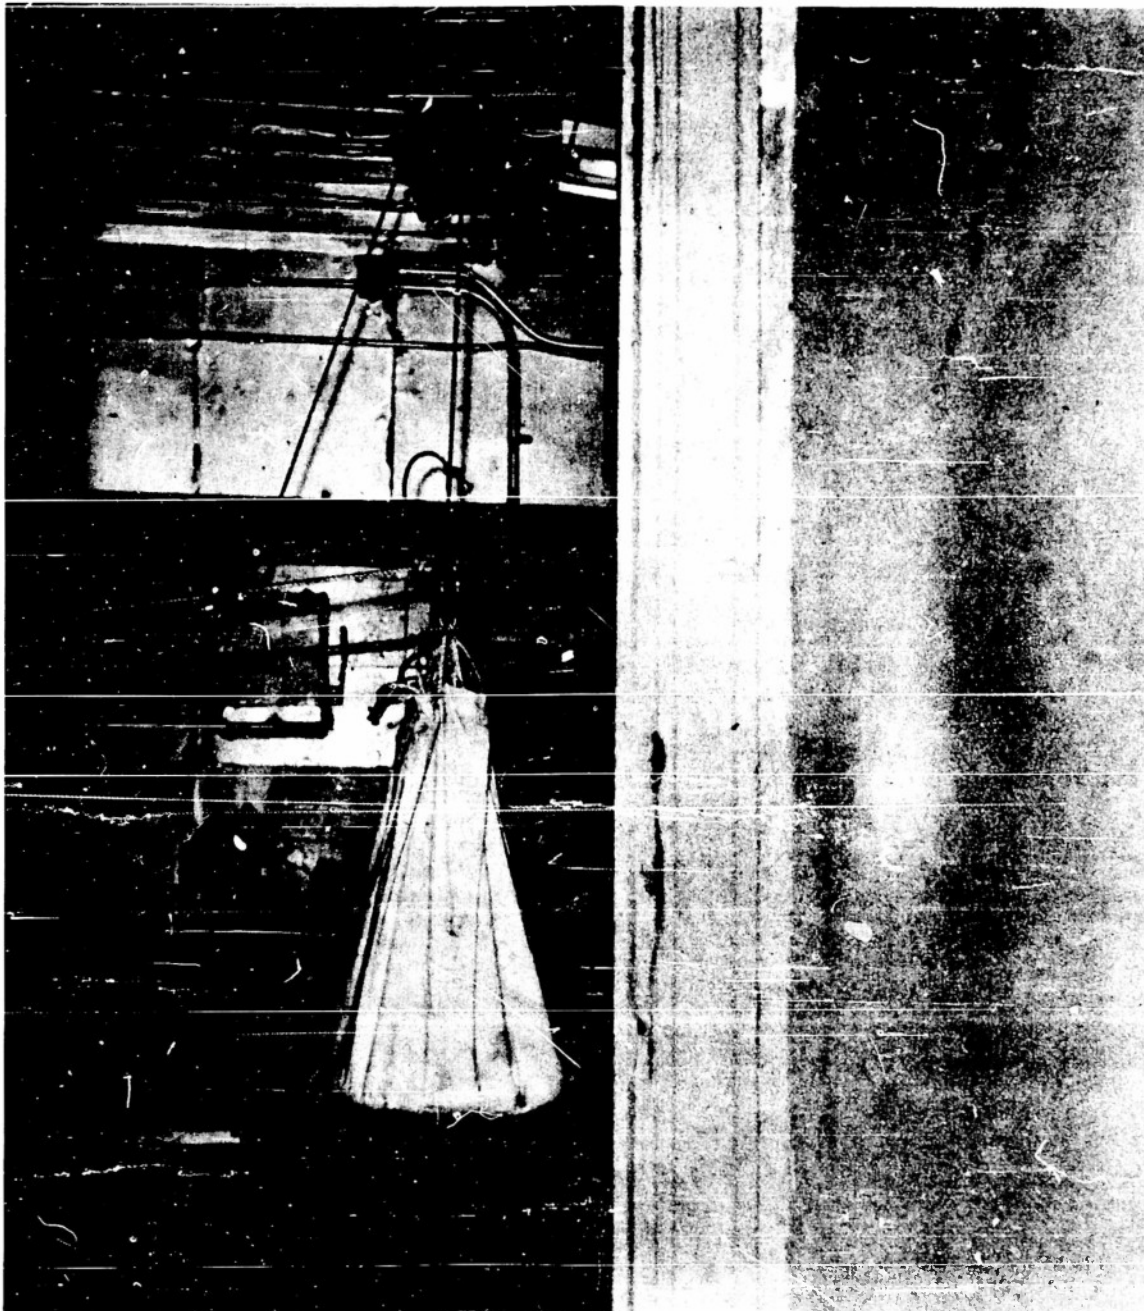
ENDURANCE TEST APPARATUS "UP POSITION"

6. One litter of each type not subjected to procedure No. 5 above was tested for endurance. The test consisted of loading and unloading the litters with weights totaling 400 pounds for 10,000 cycles. The points of suspension and pattern of loading were according to procedure No. 5a. The cycle frequency was ¾ cycles per minute with an amplitude of approximately 4 inches. The litters were examined for failures, permanent set, and deflection under load after each 1000 cycles and at the conclusion of the test. Figure 3 shows the endurance test system in the "up position" while Figure 4 illustrates the system in the "down" position.

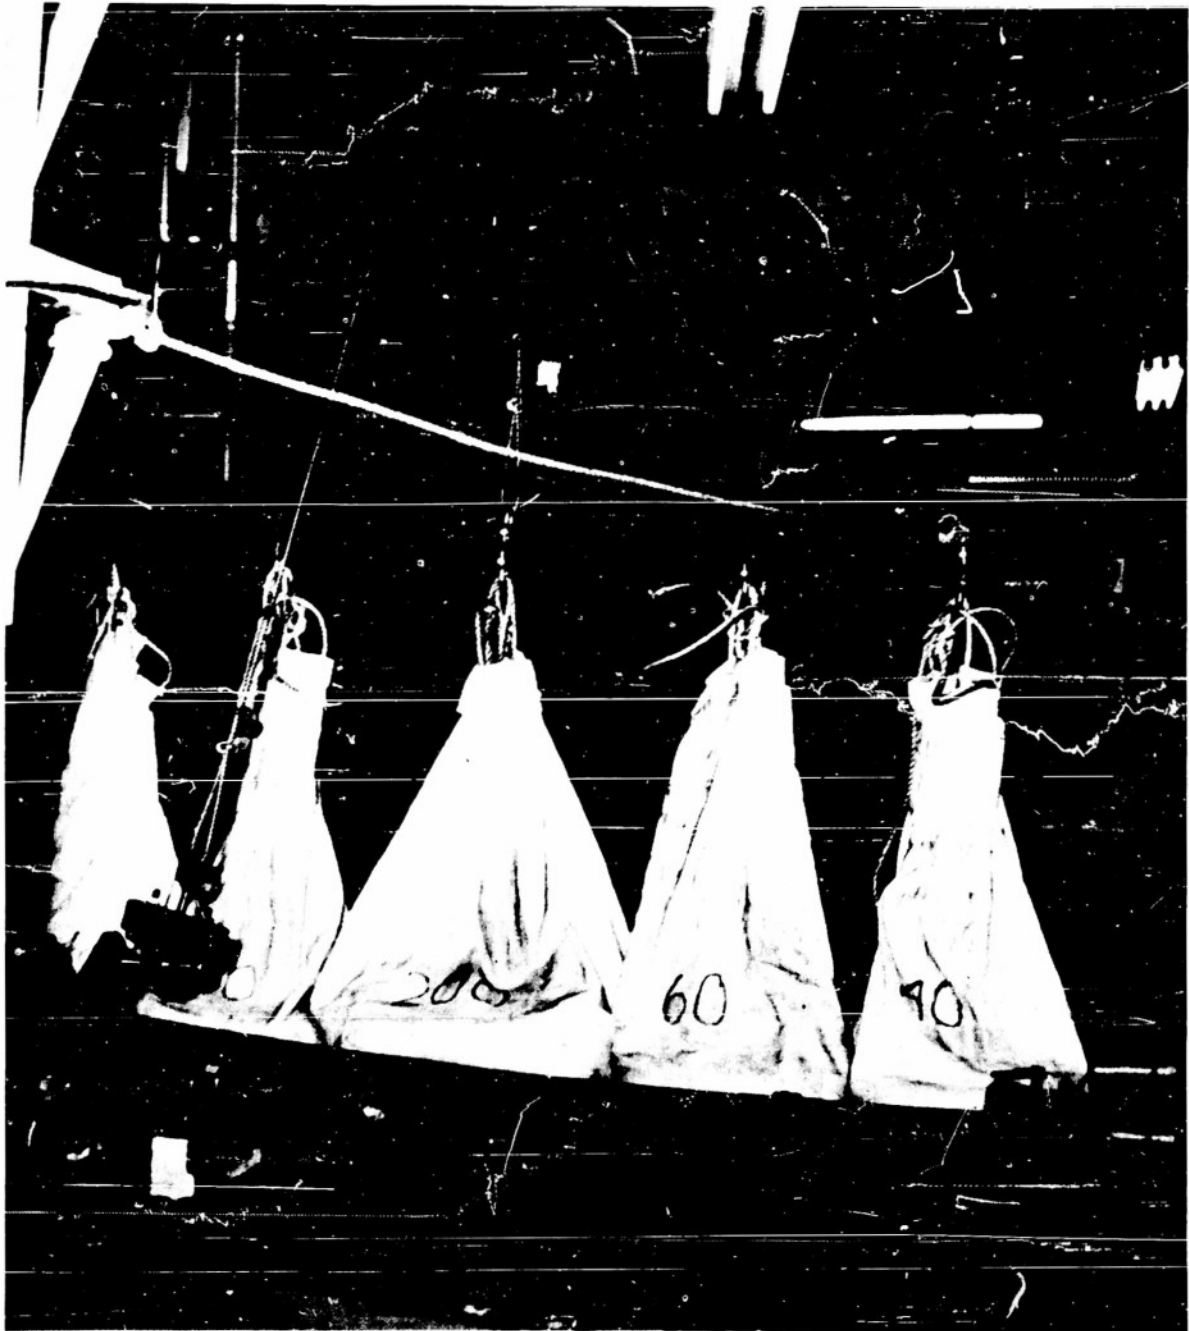
Figure 4

ENDURANCE TEST APPARATUS "DOWN POSITION"

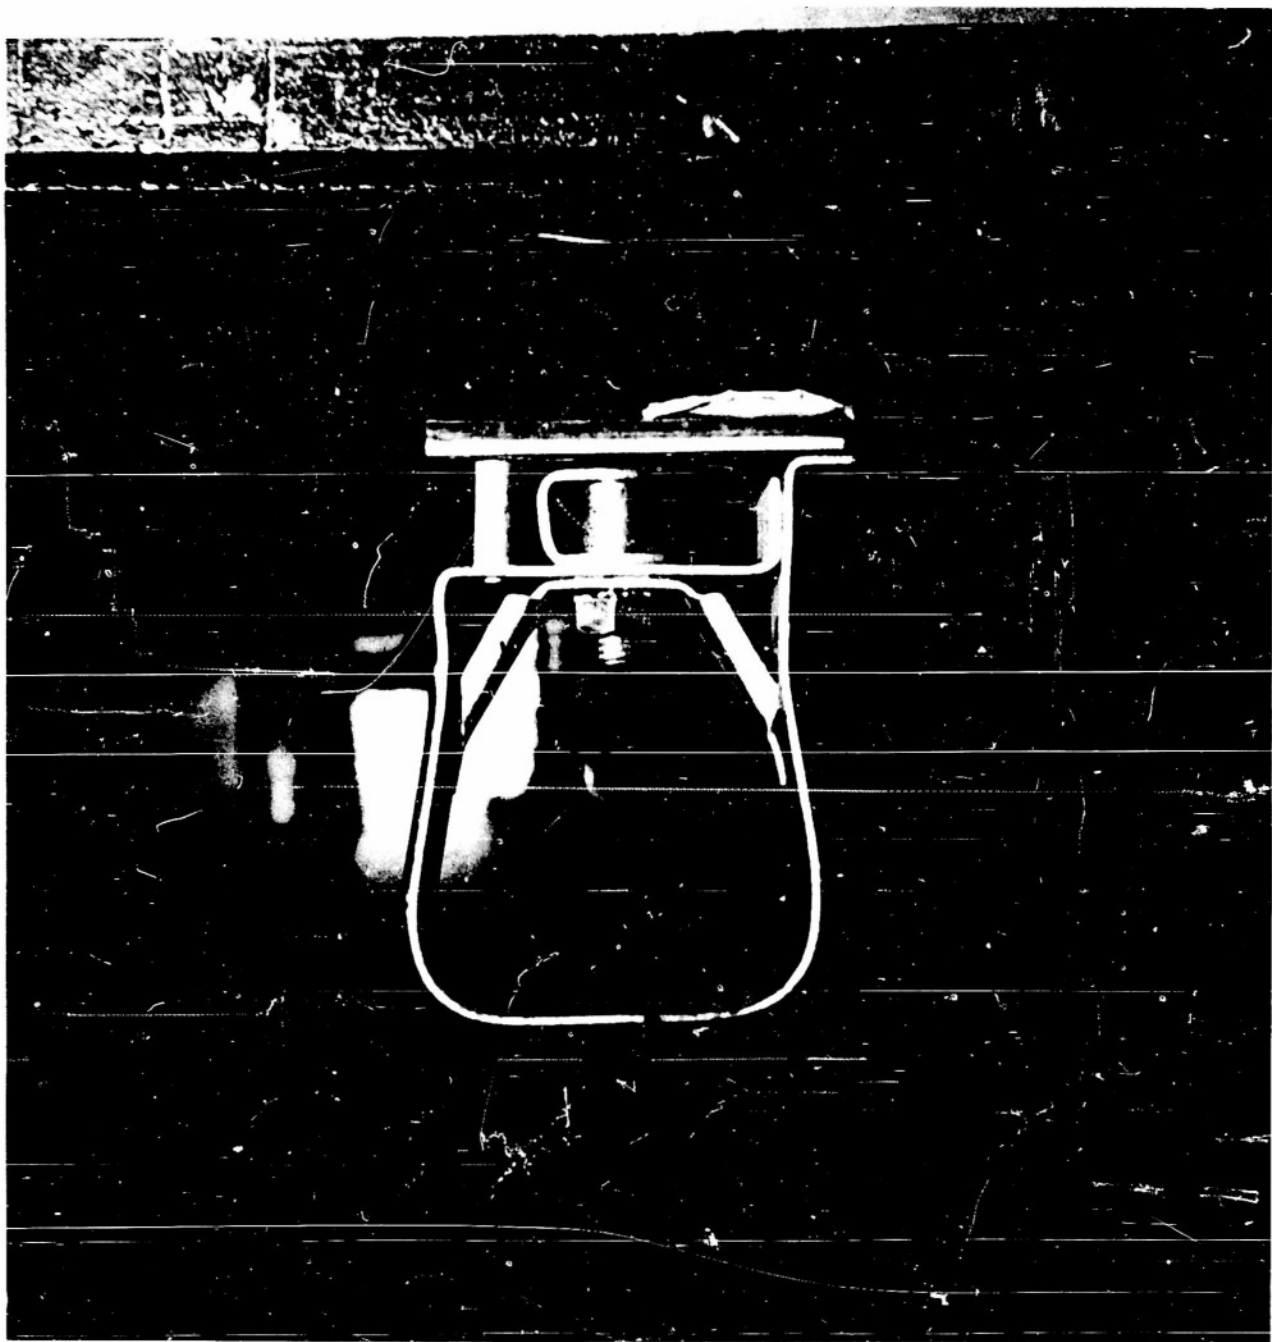
Figure 6

STIRRUP ASSEMBLY ALUMINUM POLE LITTER

Figures 5 and 6 show the typical stirrup assemblies of litters Nos. 1 and 3 respectively. Note the thinner material used for the stirrup of litter No. 3 (see Table I - Thickness of Stirrup Stock)

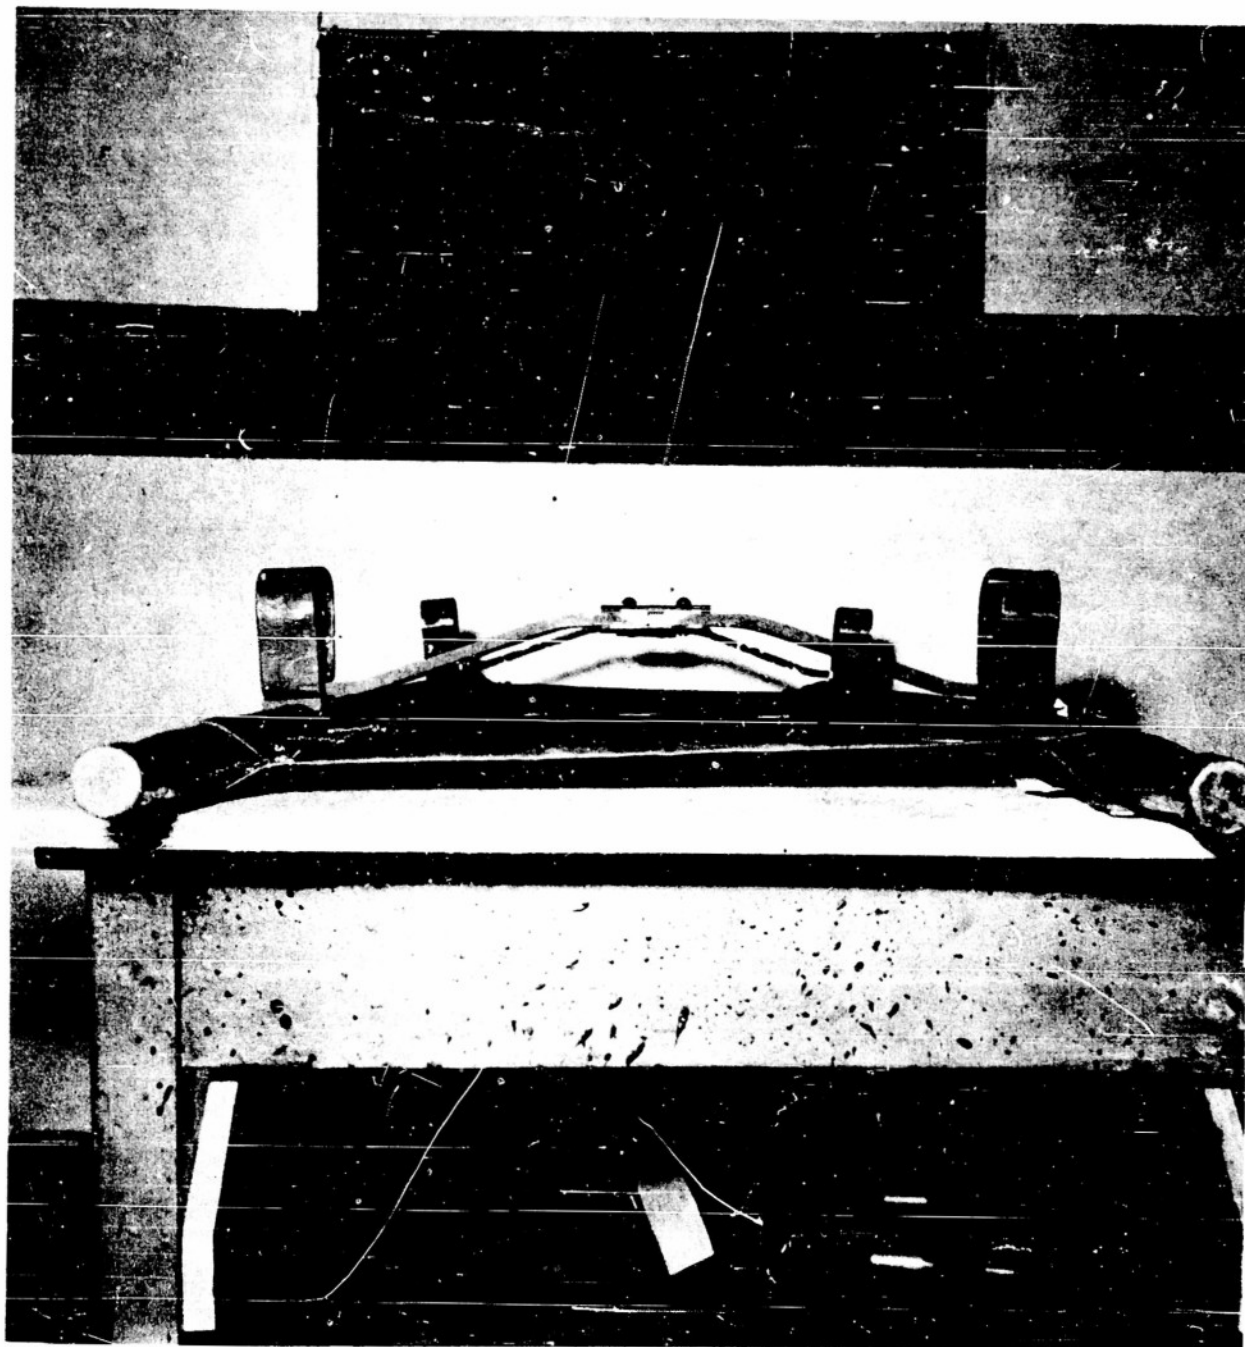
Figure 7

END ON VIEW PLYWOOD POLE LITTER

Figures 7 and 8 are "end on" views of litters Nos. 1 and 3 respectively in the "upside down" position. Observe the corrugations on the stirrups and the channel-type construction of the spreader bars of litter No. 3. Also there is a coupler connecting the two spreader bars of litter No. 1 while a pin connects the spreader bars of litter No. 3. The "end on" view of litter No. 6 is similar to that of litter No. 1 excepting there is a taper to the stirrups of litter No. 6.

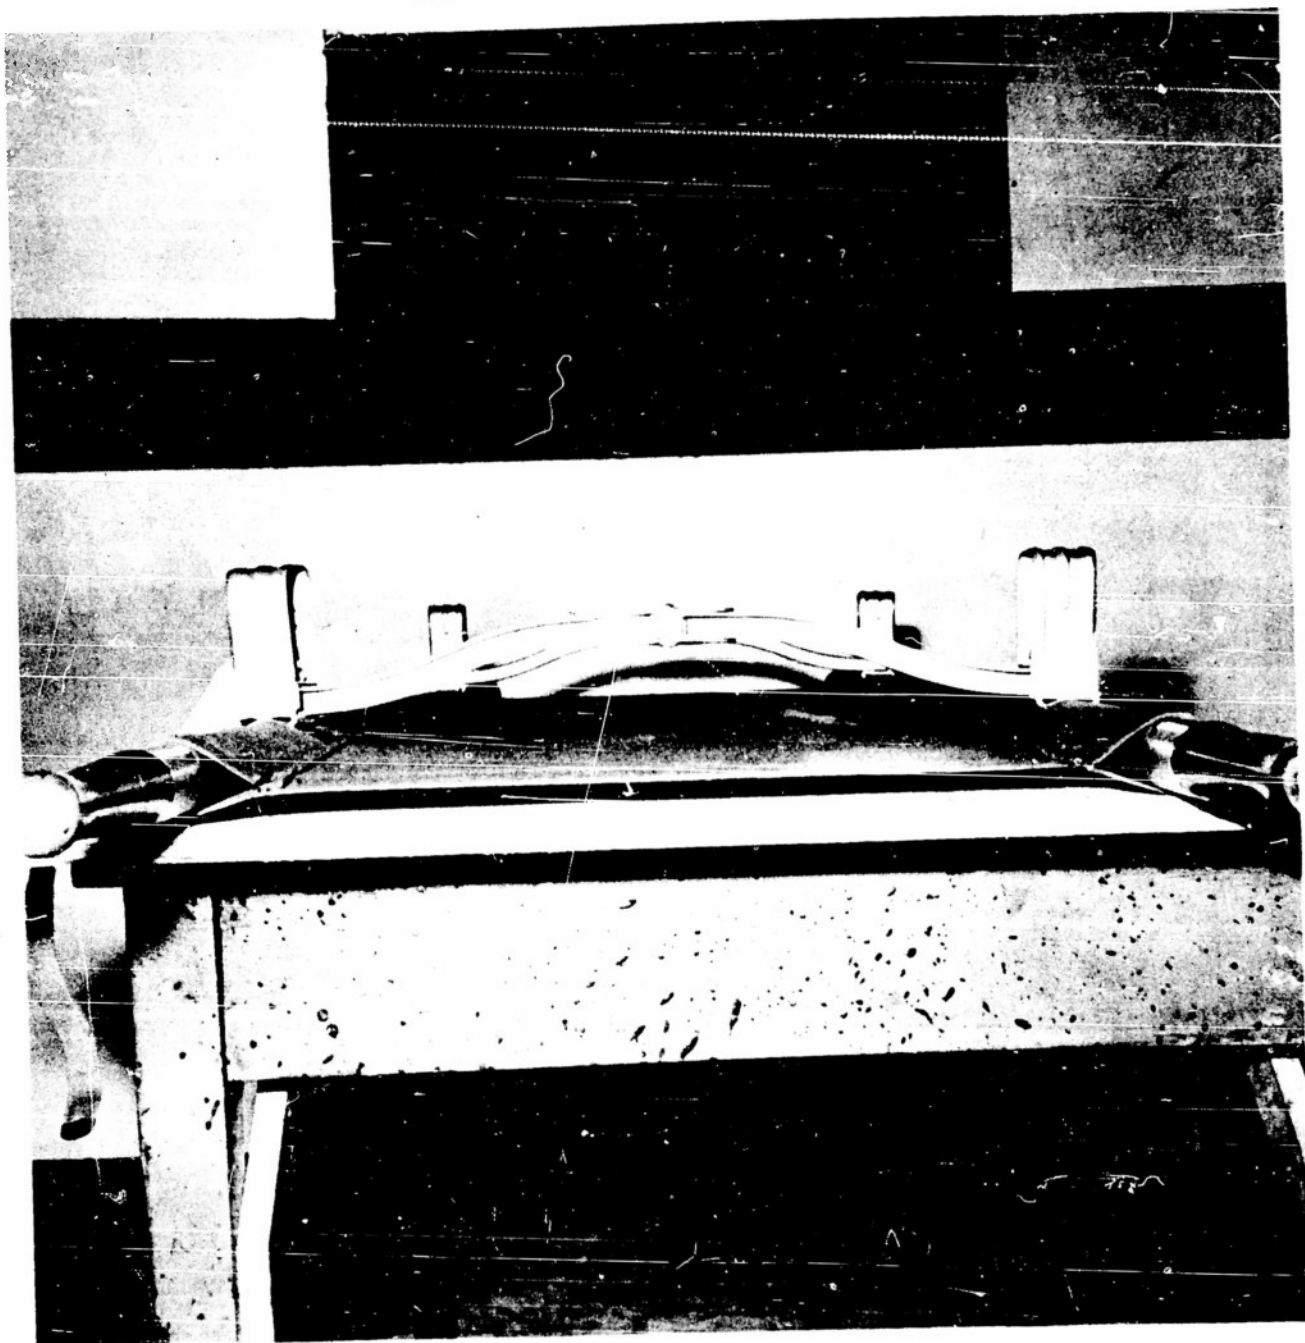
Figure 8

END ON VIEW ALUMINUM POLE LITTER

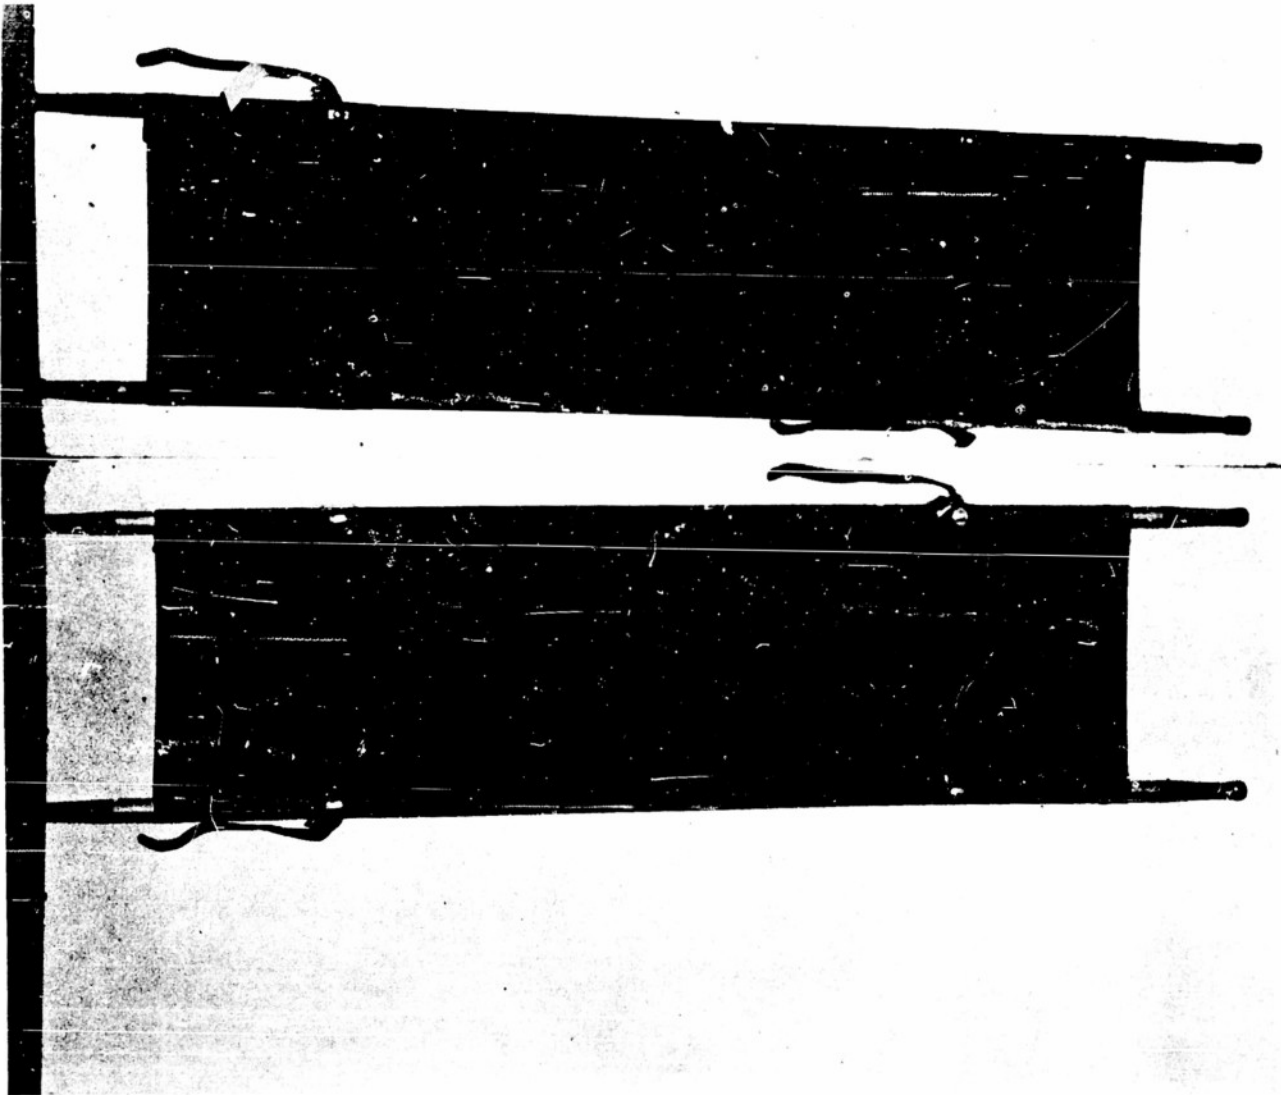
Figure 9
TOP VIEW LITTERS

Figure 9 is the "top" view of litters No.1(on the left) and No. 3. Note that there are no transverse fold lines on the canvas cover of litter No. 3.

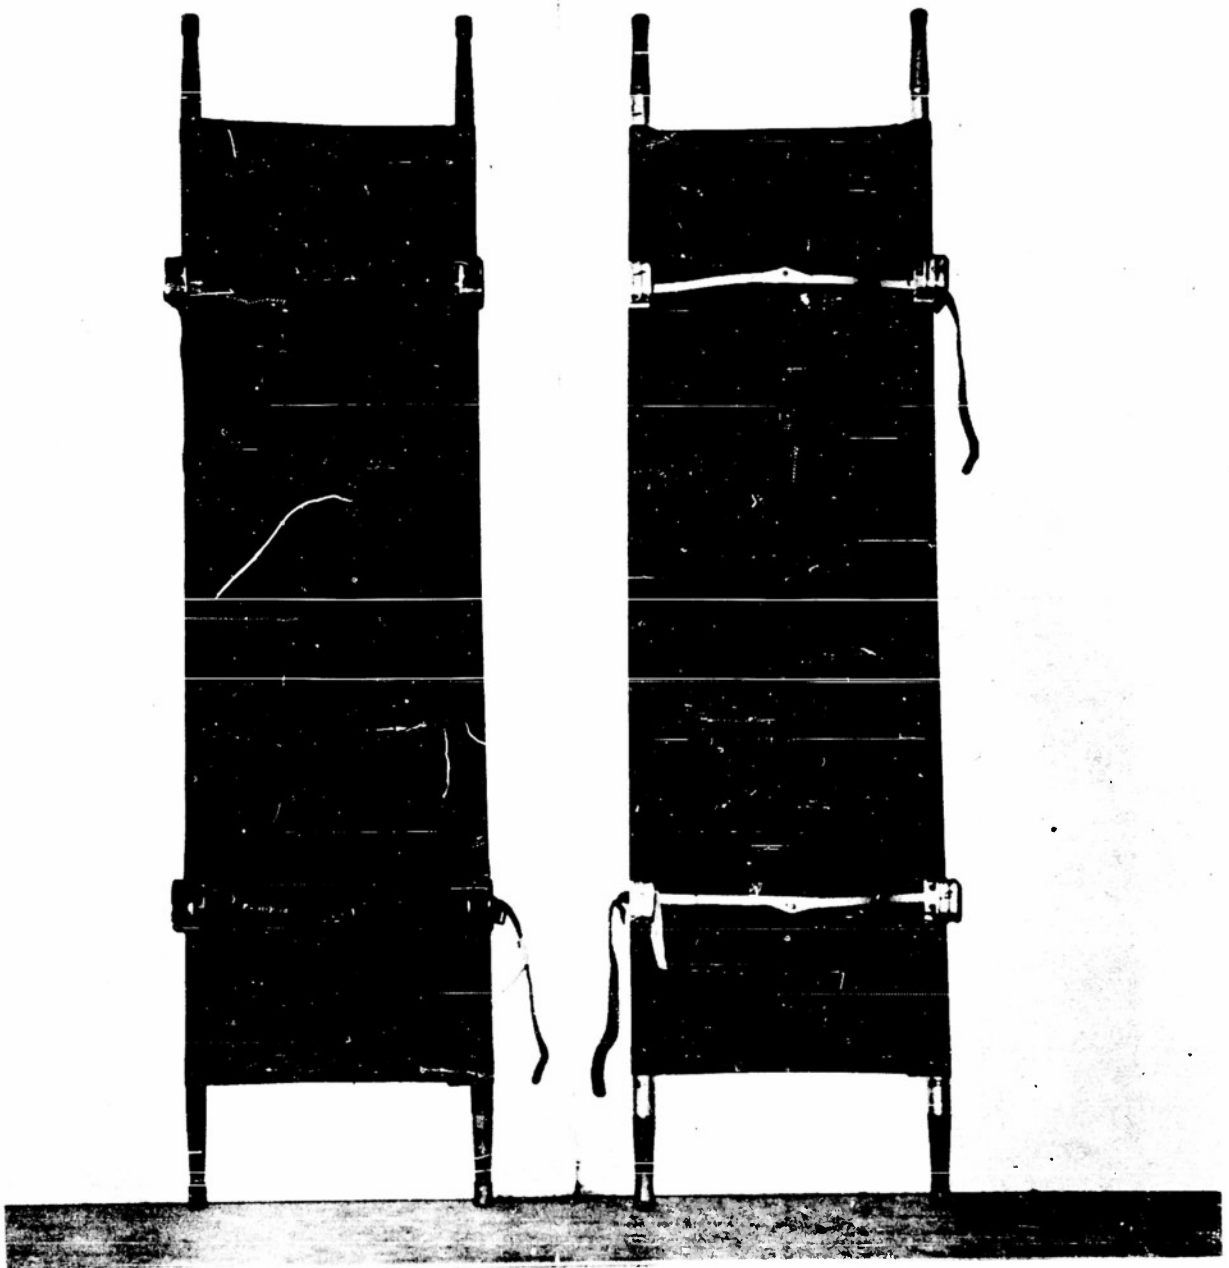
BOTTOM VIEW LITTERS

Figure 10 is the "bottom" view of litters No.1(on the left) and No. 3. This view illustrates the method of numbering parts of the litters.

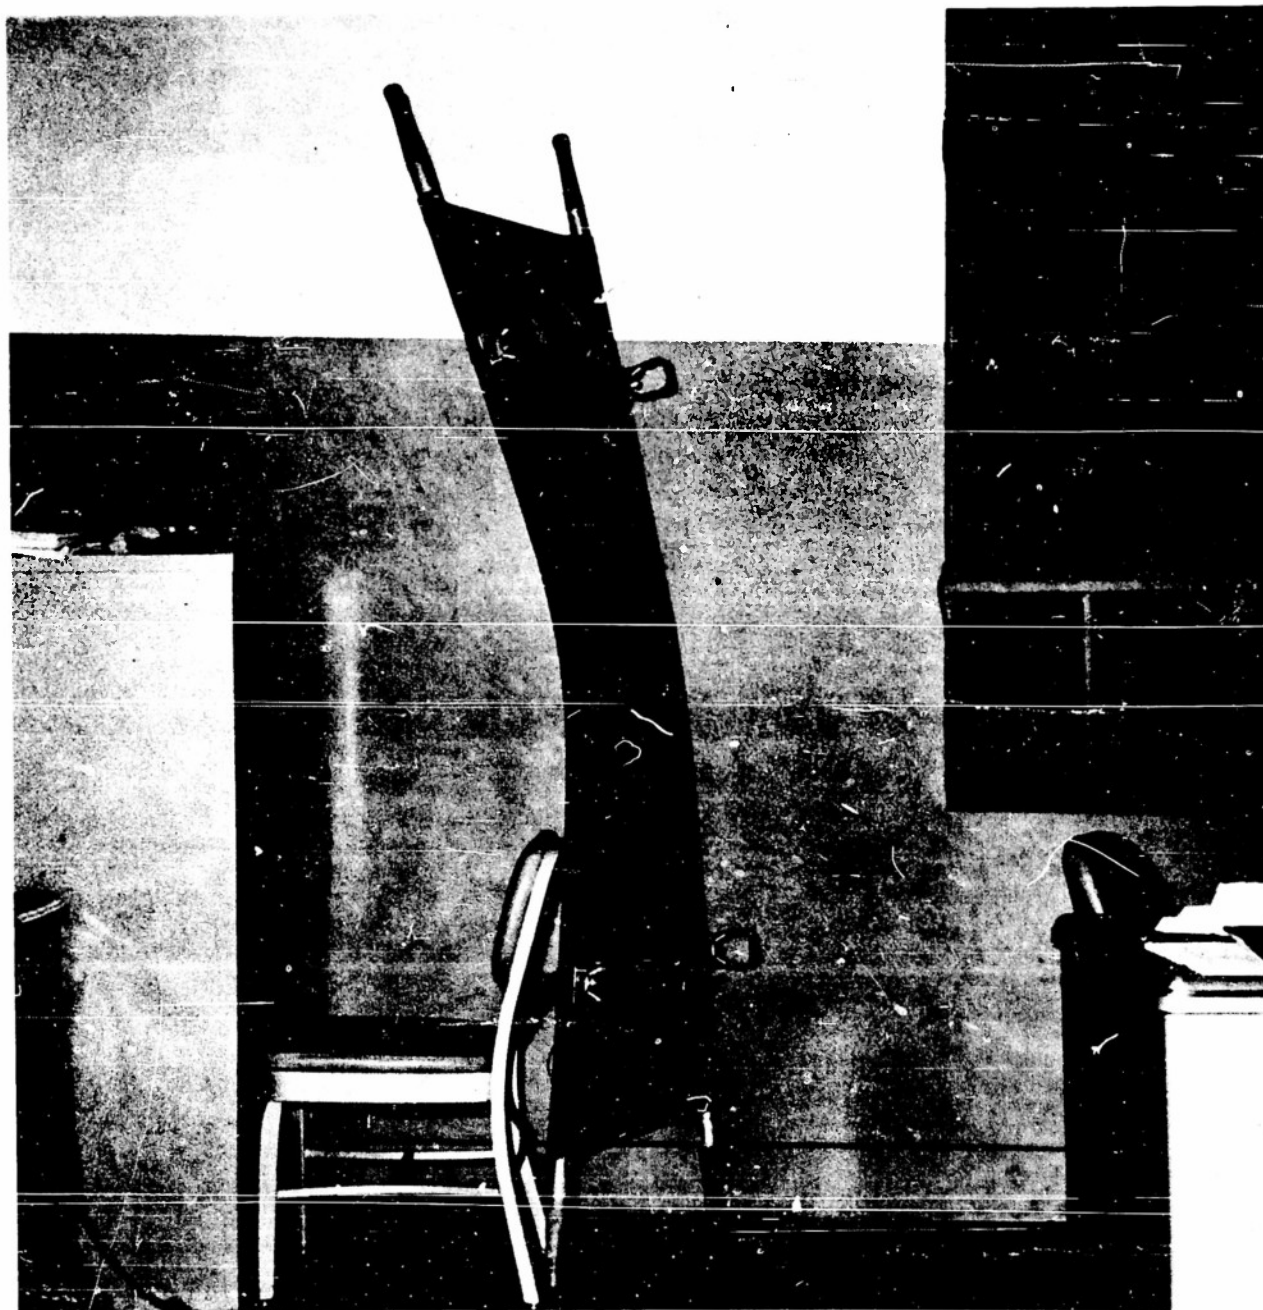
Figure 13

LITTER No. 3 AFTER "ULTIMATE STRENGTH" TEST

Figures 13, 14, 15 and 16 show the collapsed poles of litters Nos. 3-6 respectively. Note the permanent sets in the other poles.

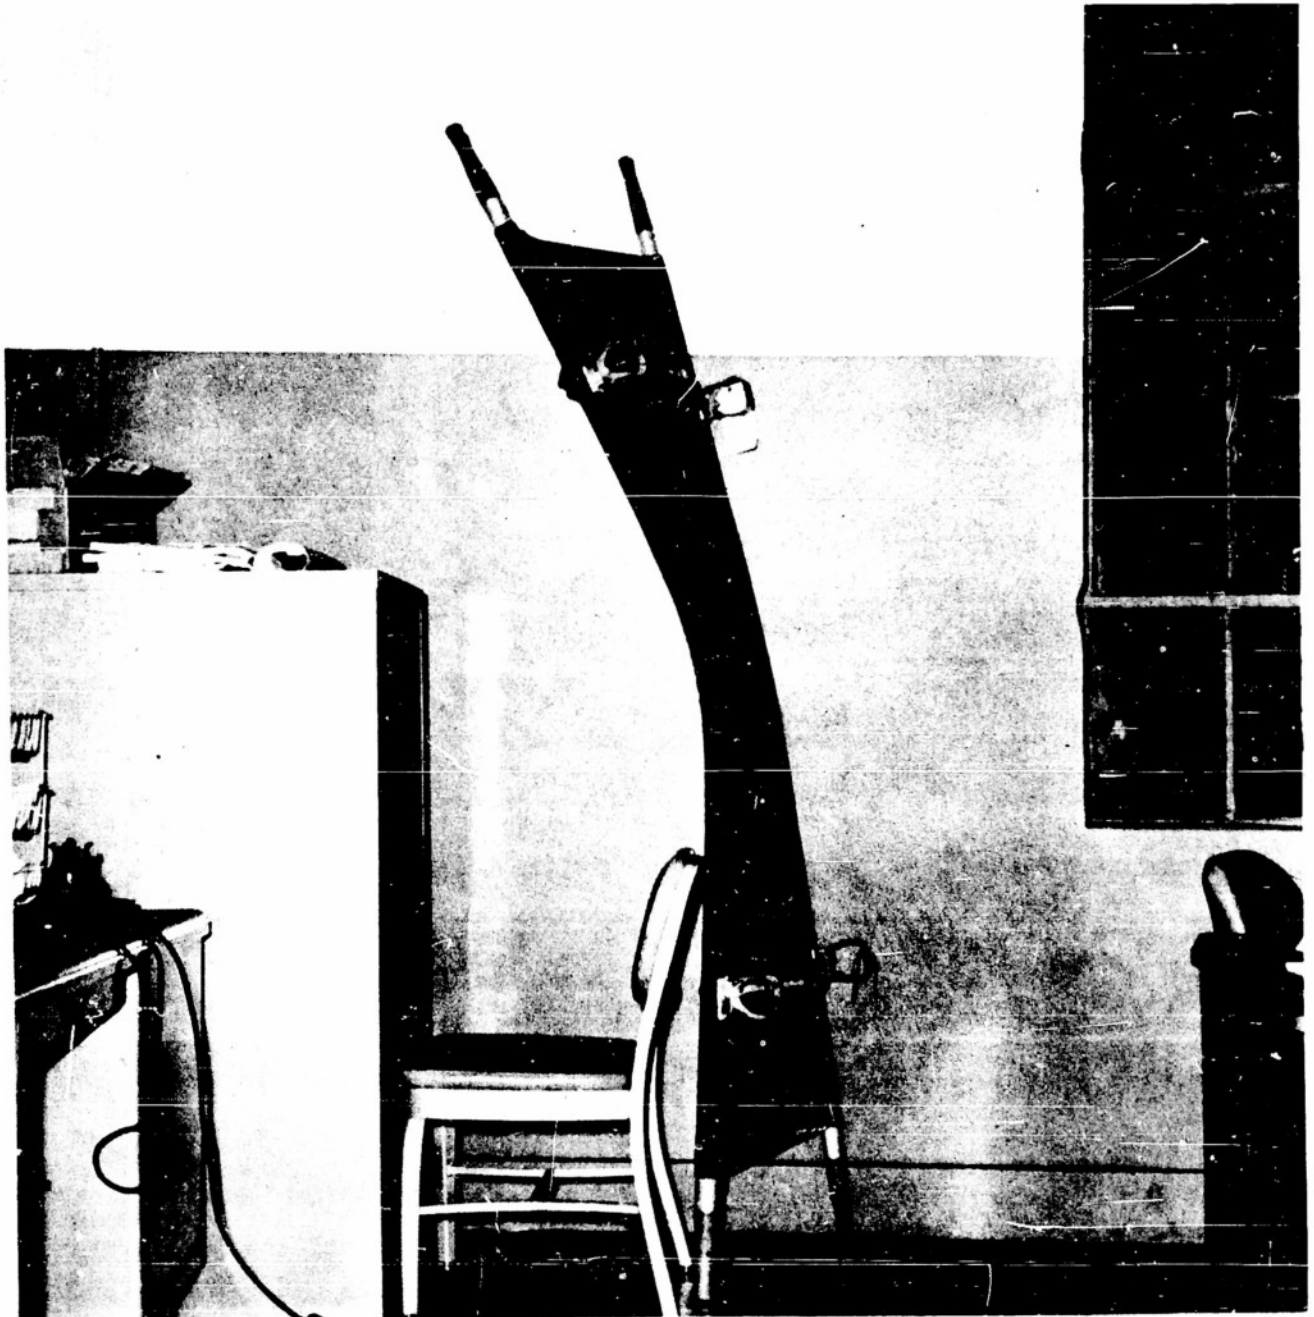
Figure 14

LITTER No. 4 AFTER "ULTIMATE STRENGTH" TEST

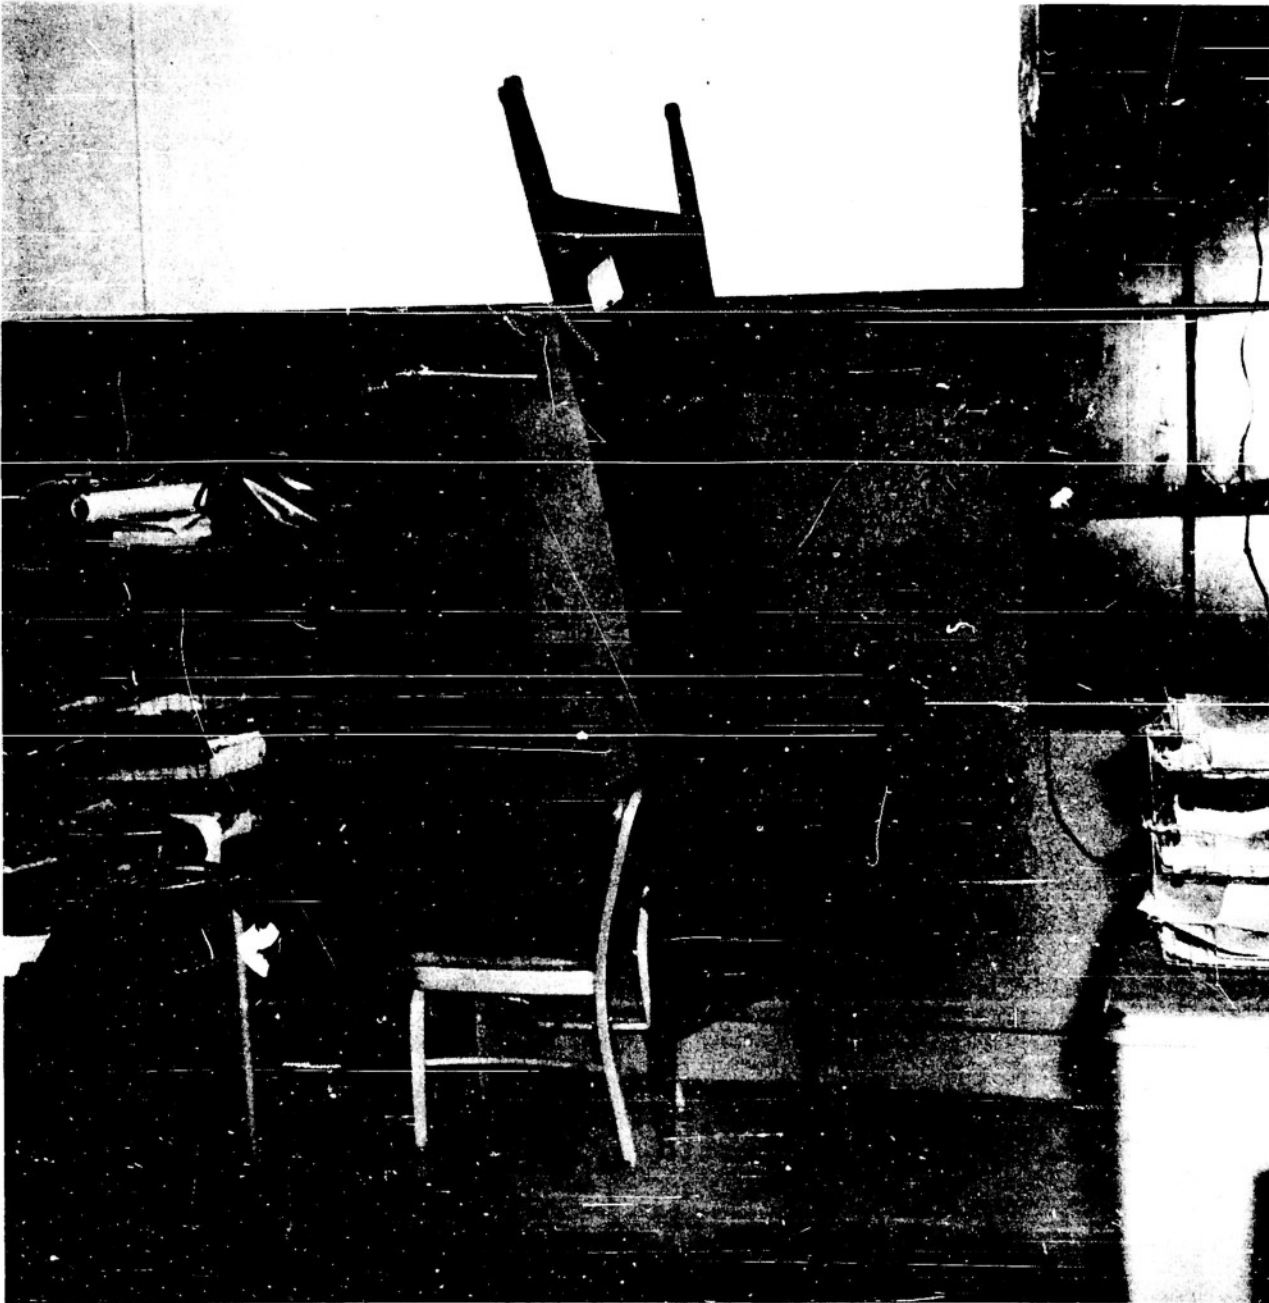
Figure 15

LITTER No. 5 AFTER "ULTIMATE STRENGTH" TEST

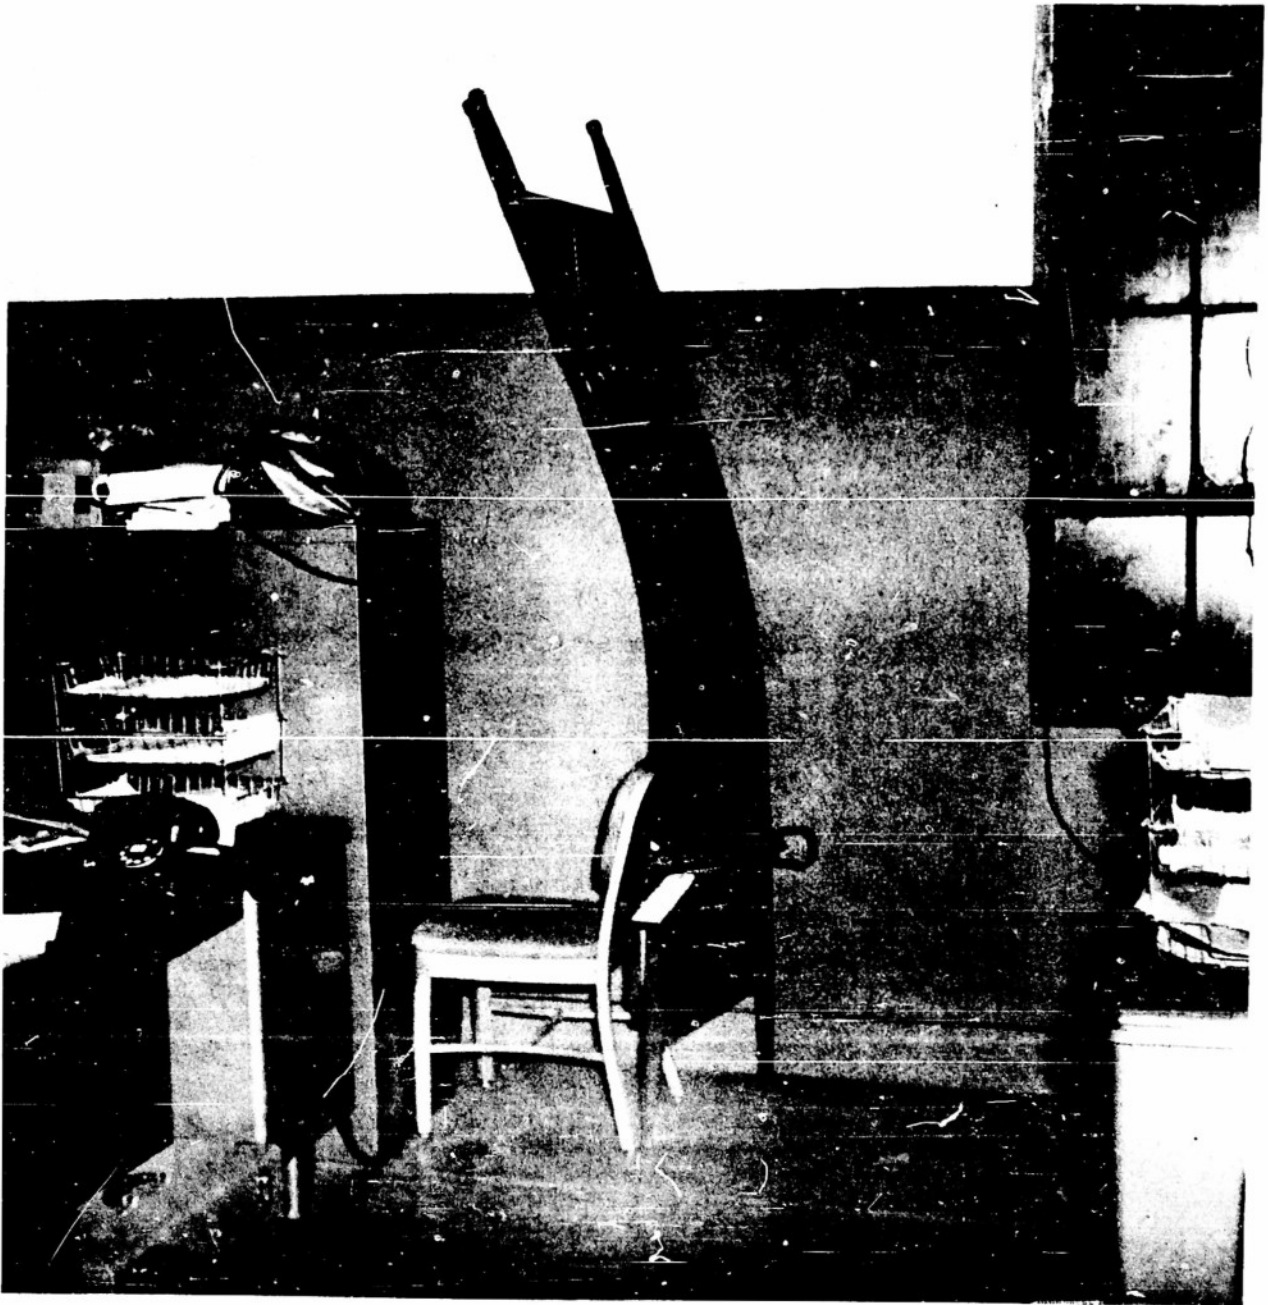
Figure 16

LITTER No. 6 AFTER "ULTIMATE STRENGTH" TEST
